NISSAN DIESEL AMERICA, INC.

RECALL BULLETIN 03V-010

VOLUNTARY SAFETY RECALL CAMPAIGN NUMBER 03V-010: 2003 MODEL YEAR UD1800CS, UD1800HD, UD2000 AND UD2300 MODEL VEHICLES PROPELLER SHAFT INSPECTION AND REPLACEMENT

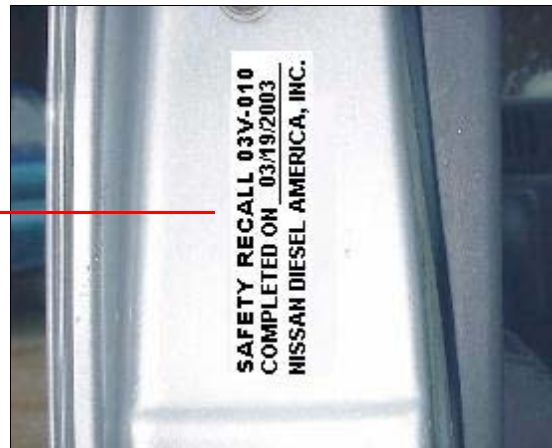
**THIS LABEL INDICATES THAT THE VEHICLE
HAS BEEN PREVIOUSLY REPAIRED**

1. Some vehicles may have been previously repaired, indicated by the label placed on the inside of the driver's door above the latch as shown below.

- If the involved vehicle has the label on the inside of the driver's door as shown above, the recall has already been performed and no further action is required.
- If the involved vehicle does not have the label on the inside of the driver's door, verify through the Vehicle Service Notification screen of the NDANET2 system that the recall is required. Complete the safety recall, if the vehicle requires it, according to the following instructions.

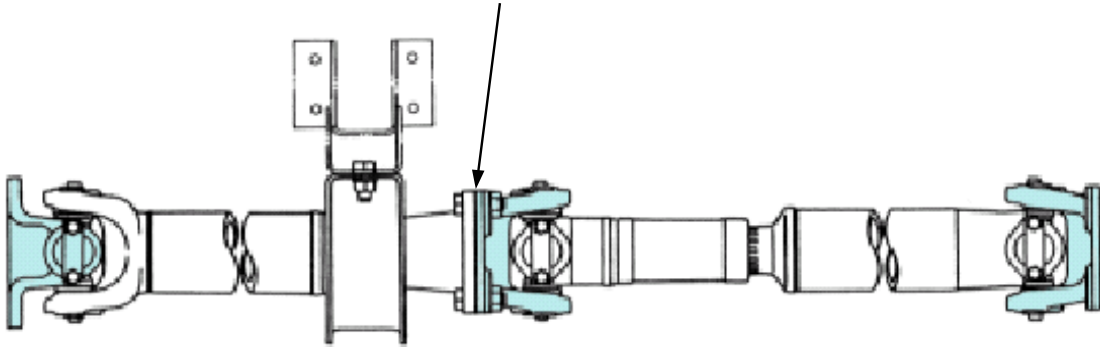
- Note the position and orientation of the drive shafts before removal. If it is necessary to install a replacement shaft, it is important that it be installed in exactly the same position and orientation as the removed shaft. Make matching marks on the yoke flanges of adjacent drive shafts.

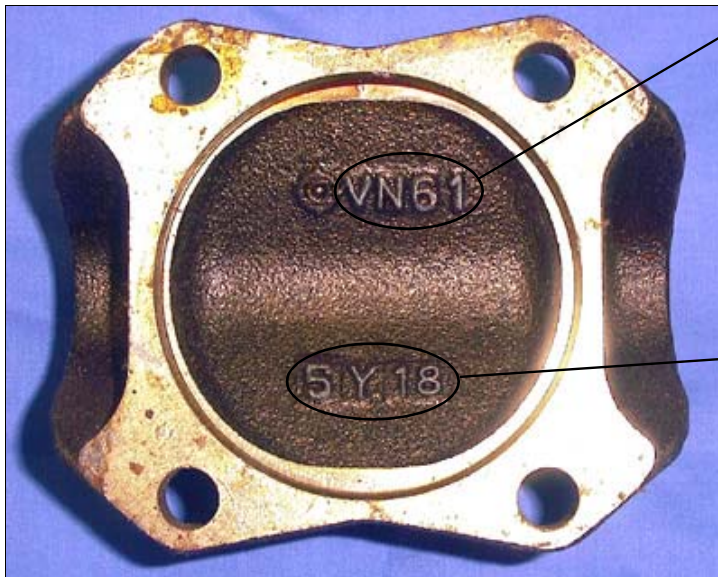
The possibility exists that the flange yoke on one or more individual drive shaft sub-sections may develop a crack in the shoulder supporting the U-joint due to improper heat treatment during manufacturing. If a crack develops in a drive shaft flange yoke while the vehicle is moving, the yoke may break and cause the drive shaft sub-sections to disengage from the transmission and possibly be ejected from under the vehicle. This will result in the vehicle becoming disabled and could potentially cause an accident or damage to other vehicles on the roadway.

- Remove all of the drive shafts from the involved vehicle. Save the nuts and bolts for reinstallation.
- Mark each removed drive shaft as either #1, #2 or #3 depending on its position in the driveline, with #1 being closest to the transmission.
- Inspect the manufacturing and date codes stamped into the yoke flanges as shown below.

If the manufacturing code stamped in the upper position is:

MN12 or MN22 . .

if the date code stamped in the lower position is:

2728, 2731 or 2802 . .

**. . THE DRIVE SHAFT ASSEMBLY
MUST BE REPLACED.**

- Any combination of the manufacturing and date codes in the upper position (MN12 or MN22) **and** in the lower position (2728, 2731 or 2802) as illustrated above requires the replacement of the affected drive shaft.
- Reinstall the drive shafts if the manufacturing and date codes differ from the five numbers listed above.
- Dealers are requested to record the manufacturing and date codes of the drive shafts that are not replaced. This information should be recorded on the service department repair order and then entered into the "Repairs Made" field of the UD Warranty Claim.
