# RECALL BULLETIN 05V-34I

DATE: OCTOBER 11, 2005  
 MODEL YEAR: 2005 thru Early Production 2006  
 CHASSIS MODEL: UD1800HD, UD2000, UD2300, UD2600, UD3300  
 BULLETIN NUMBER: SC-341

## VOLUNTARY SAFETY RECALL CAMPAIGN NUMBER SC-34I : EXHAUST PIPE REPLACEMENT

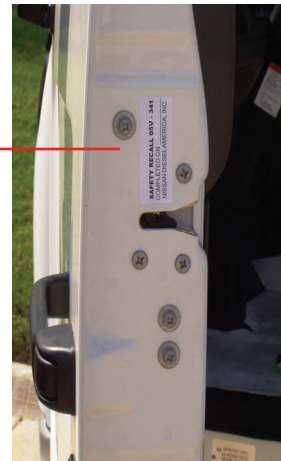
**Figure A**

- If the involved vehicle has a label on the inside of the driver's door as shown in Figure A, the recall has already been performed and no further action is required.
- If the involved vehicle does not have the label on the inside of the driver's door, verify through the Vehicle Service Notification screen of the NDANET2 system that the recall is required. Complete the safety recall according to the following instructions.
