TECHNICAL BULLETIN GE-35/TR-22

DATE: JANUARY 17, 2006
MODEL YEAR: 2005 & AFTER
TRANSMISSION: MLS63B MANUAL TRANSMISSION
CHASSIS MODEL: UD1800HD ~ UD3300
BULLETIN NUMBER: GE-35/TR-22
FILE IN THE GENERAL AND TRANSMISSION SECTIONS OF THE TECHNICAL BULLETIN BINDER

MLS63B COUNTERSHAFT END PLAY CLARIFICATION

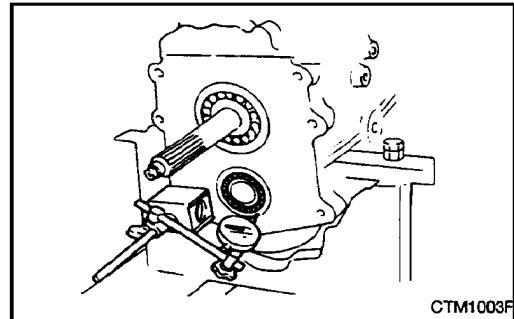
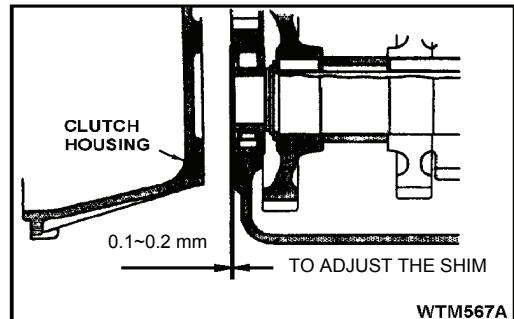
The 2005 & 2006 UD Trucks Service Manual CD's utilize the incorrect wording for the MLS63B countershaft end play measurements and adjustment procedure.

NOTE: The countershaft end play has increased in the 2005 MY with the introduction of the MLS63B transmission and the J08-TE engine.

Select shims and install so that they are recessed below the transmission case end surface by 0.1 to 0.2 mm (0.004 to 0.008 in). The thicknesses of the shims are 0.1, 0.2 and 0.3 mm (0.004, 0.008 and 0.012 in)
